Technical Service Bulletin

DSR-M810 Firmware Update via Front Panel USB

TSB Overview: M810 Y2010 Update

**Bulletin No:
IR-TSB010610**

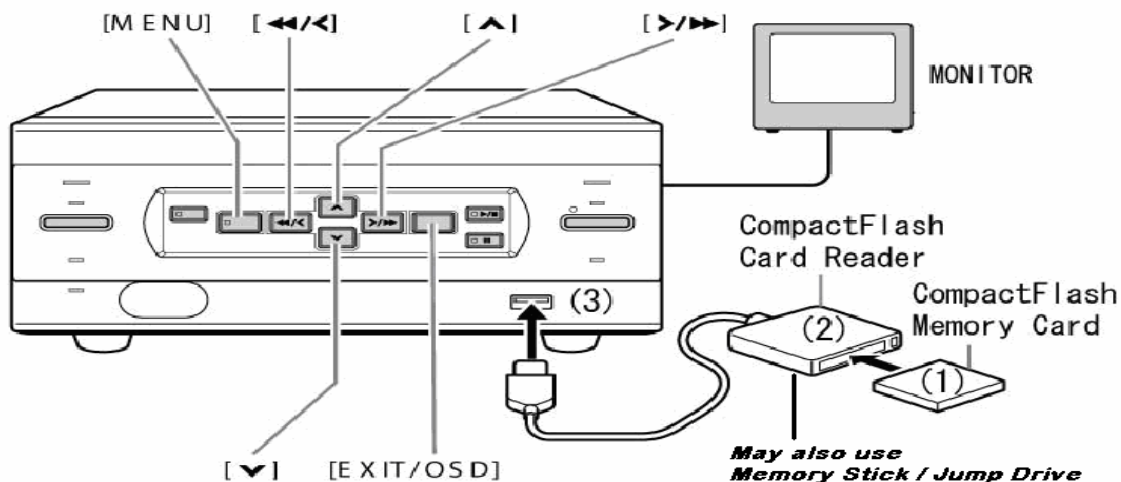
A local analog video monitor must be connected to the Video Output BNC post at the rear of the DSR unit.

1. Press the Menu Key to display the MAIN MENU
