# Technical Service Bulletin

**Bulletin No:  
IR-TSB010710**

## DSR-M814 Firmware Update via Front Panel USB

## TSB Overview: M814 Y2010 Update

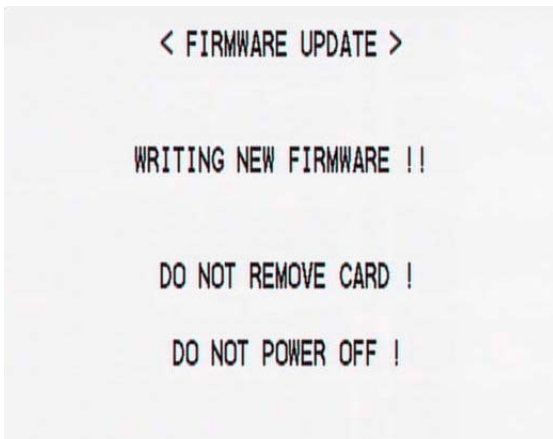
9. Press the **[>/▶▶]** key to start updating the firmware. The LED lamps on the front panel blink.

10. The update is completed once the device has restarted twice. (After the device powers down and automatically restarts twice.)
